We asked Gordon Wilson, from National Grid's Network Engineering team: Is the industry dealing with its transformer's corrosive sulphur problem? Or can we stop worrying about it?

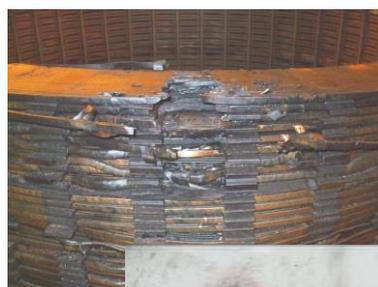
A failed winding where copper sulphide was a factor in the failure

We had a failure in 2007 where copper sulphide played a part and we have been conducting research into the best way to manage the problem ever since. We took a risk-based approach to the problem and have used sulphur removal and passivation to manage the problem.

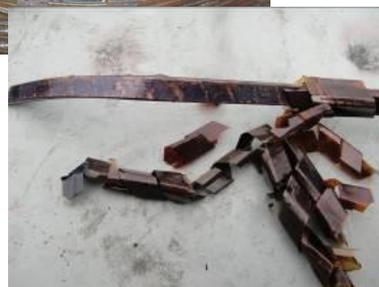
Evidence of copper sulphide from a retired transformer

Having looked at passivator effectiveness in the laboratory we then asked the researchers at Southampton to look at copper conductors taken from transformers removed from service at the end of their lives to confirm that the passivator was successful in getting where we wanted it to go.
